1. PROJECT BACKGROUND

Applied Pavement Technology, Inc. (APTech) has teamed with Coffman Associates (Coffman), assisted by Garver, to update the Pavement Management Program (PMP) for both airside and select landside pavements at Corpus Christi International Airport (CCIA) for the City of Corpus Christi. Results and recommendations from this PMP will assist decision-makers with identifying maintenance and repair needs to efficiently and effectively manage the existing pavement infrastructure and will ensure compliance with Federal Aviation Administration (FAA) pavement inspection requirements for CCIA.

During this update, APTech reviewed pavement records provided by the CCIA and Coffman, updated the network definition map and associated PAVER database, performed Pavement Condition Index (PCI) inspections, customized analysis inputs within PAVER, used the collected information to identify pavement maintenance and rehabilitation needs, and developed a recommended Capital Improvement Plan (CIP). Results and recommendations are presented in this report.

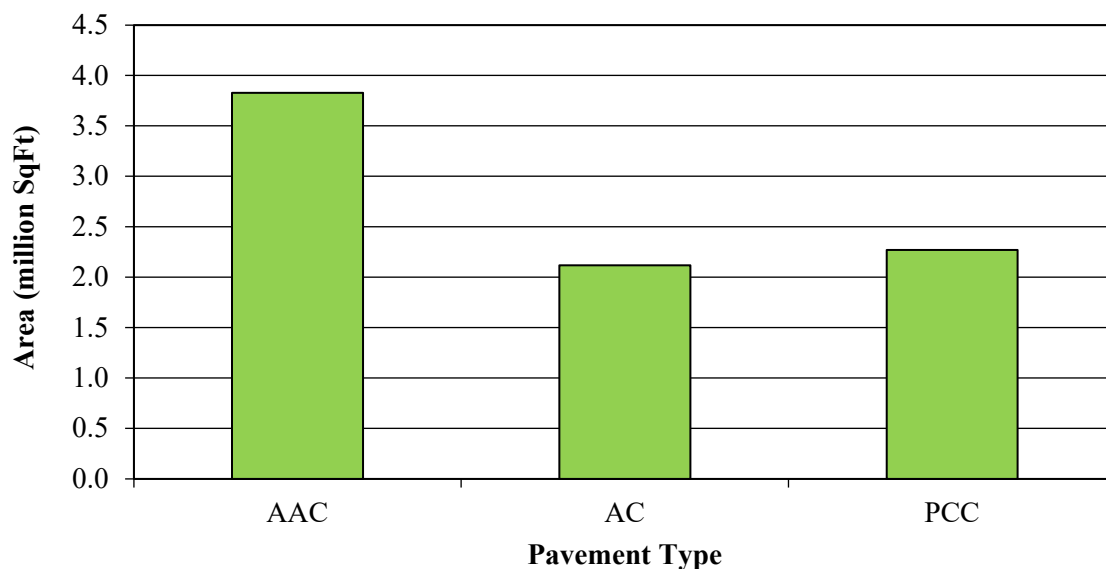
Figure 1. Pavement area distributed by pavement type.

Figures 1 and 2 show a summary of the included pavement area by pavement type and use, respectively. Pavement types, as they correspond with PAVER and as used throughout this report, are defined as follows:

As illustrated in these figures, the majority of the inspected pavement consists of AAC pavement, which represents approximately 47 percent of the area. The remaining area consists of 26 percent AAC pavement and 28 percent PCC pavement. Taxiways make up the largest portion of the pavement, representing 29 percent of the total area. Following the taxiways are the aprons and runways, which represent 26 percent and 25 percent of the total area, respectively. The runway shoulders and overruns make up 7 percent and 6 percent of the total pavement area, respectively. The inspected roadways at CCIA make up 7 percent of the total pavement area.

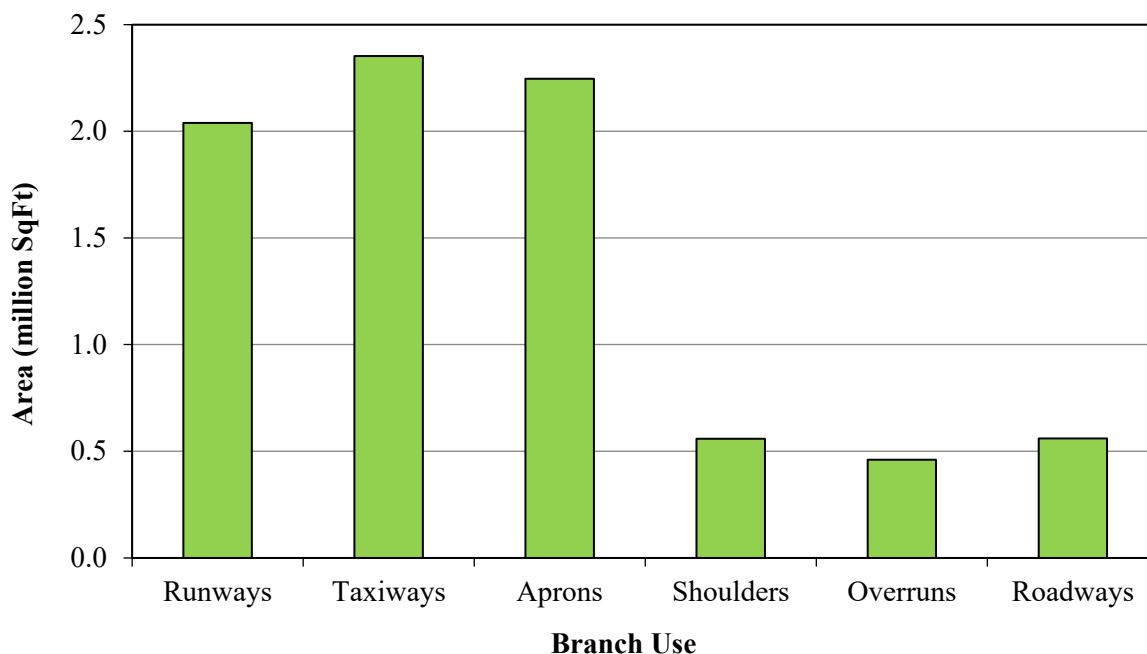
Figure 2. Total pavement area distributed by use.

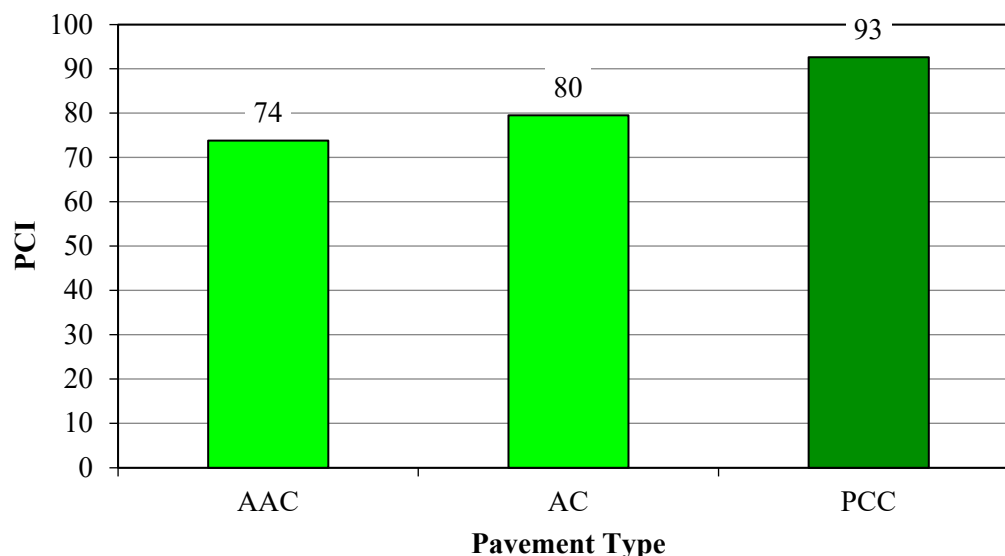
Figure 9. PCI results by pavement type.

While overall, the CCIA pavements are in SATISFACTORY condition, PCIs of individual sections range from 29 to 100. Figures 9 and 10 show the PCI results from the 2024 inspection of CCIA pavements distributed by pavement type and use, respectively.

As shown in Figure 9, the PCC pavement is in the best condition, with an area-weighted PCI of 93. Most of the PCC pavement is located within the Terminal Apron, which has undergone numerous rehabilitation and expansion projects since 2015. The overall, weighted condition of the AC and AAC pavements at CCIA is SATISFACTORY, with PCIs of 74 and 80, respectively.

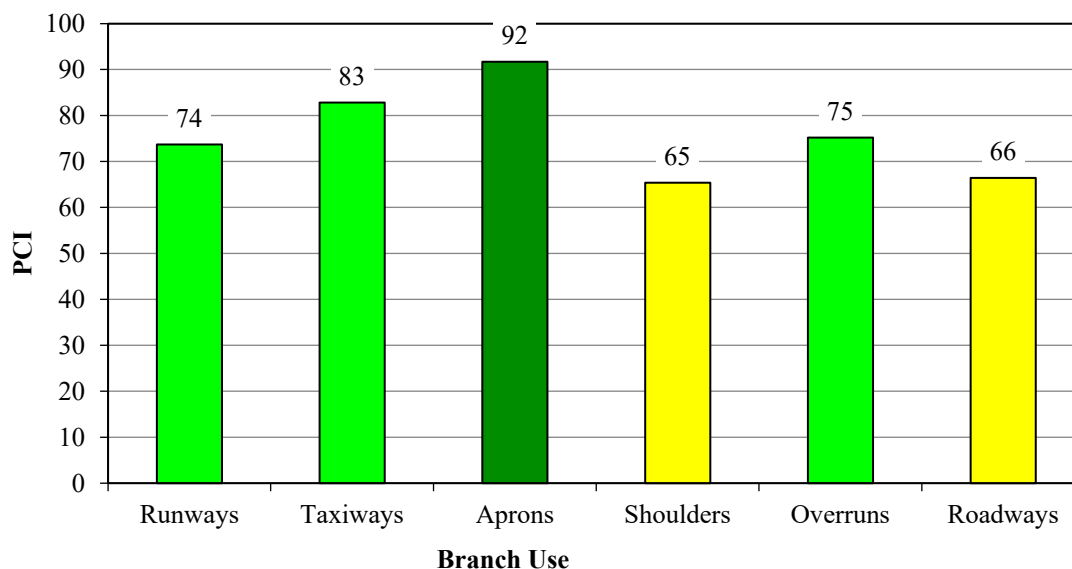
Figure 10. PCI results by use.

As shown in Figure 10, the area-weighted PCIs across the various facilities at CCIA range from FAIR to GOOD condition. Runways and taxiways are in similar condition, with PCIs of 74 and 83, respectively. The aprons are in better condition, with a weighted condition of 92, due to rehabilitation in the past ten years. The condition of the runway shoulders and overruns ranges from FAIR to SATISFACTORY, with weighted PCIs of 65 and 75, respectively. The roadways at CCIA are in FAIR condition, with an area-weighted PCI of 66.
